WOOD DESTROYING PESTS AND ORGANISM INSPECTION REPORT

Building No. 6617	Street Camelia Drive	City San Jose	ZIP 95120	Date of Inspection 5/1/2009	Number of Pages Page 1 of 3
-----------------------------	--------------------------------	-------------------------	---------------------	---------------------------------------	---------------------------------------

General Description: One story, single family wood framed residence with stucco exterior.	Inspection Tag Posted Garage Other Tags Posted None Noted
--	--

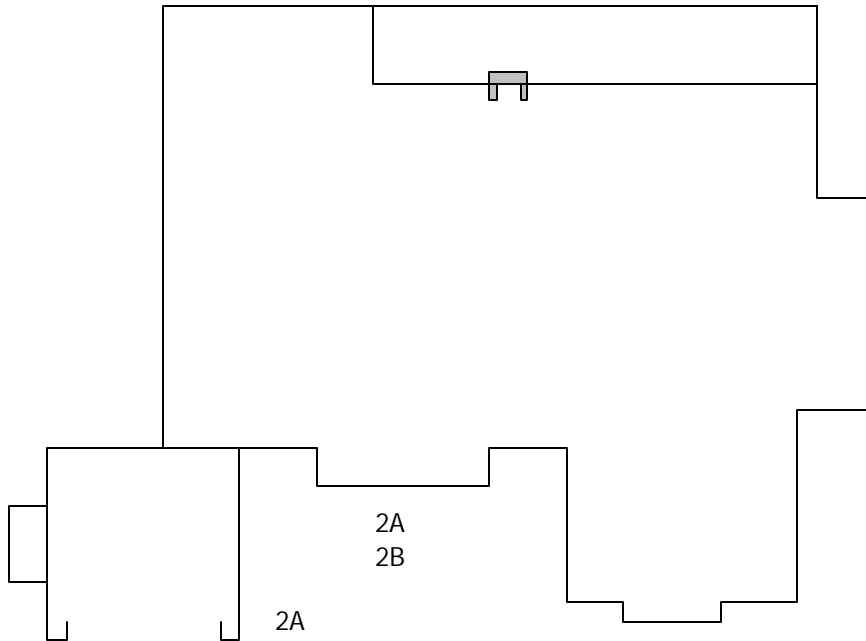
Diagram Not To Scale

2A. FINDING: There is a faulty grade condition as indicated on the diagram. A faulty grade condition exists when the earth's level is even with or above the top of the adjacent foundation.

2B. FINDING: The exterior caulking at the trim is missing.

RECOMMENDATION: Grade the earth in this area to maintain an earth level below the top of the foundation and to provide proper drainage away from the structure.

RECOMMENDATION: Install new exterior grade caulking to prevent future moisture intrusion.
